Influence of different shaft surface finishes on the tribological and functional behaviour of radial shaft seals

Schulz, Markus

Universität Stuttgart

Institut für Maschinenelemente – IMA
Bereich: Dichtungstechnik

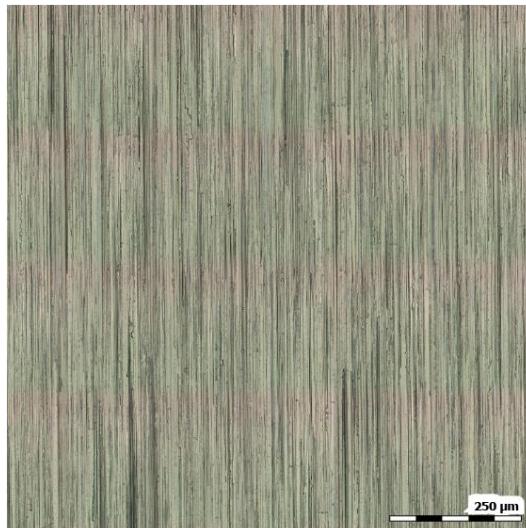
Plunge ground shaft counterface

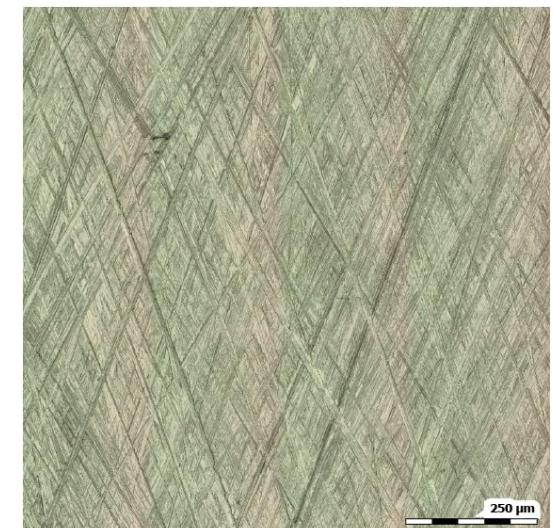
Superfinished shaft counterface

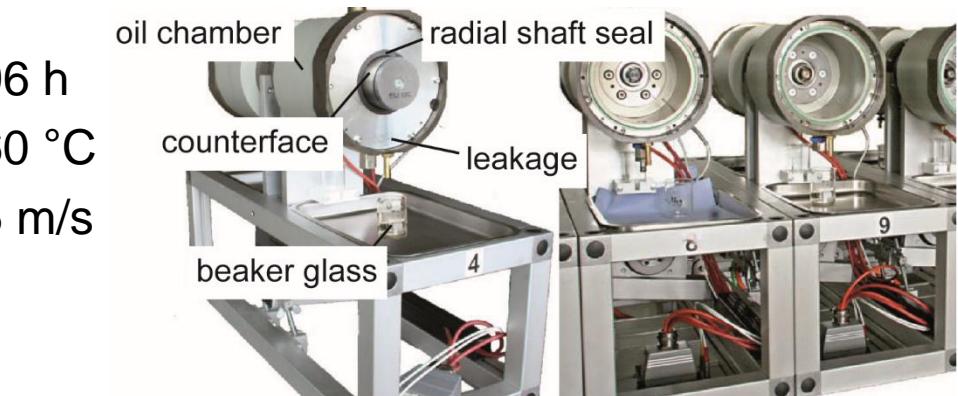
- Endurance tests
 - Duration
 - Oil sump temperature
 - Circumferential speed
- Friction measurement
